SUBJECT: Site Inspection, Deseret Generation and Transmission, Diamond Mountain Quarry, M/047/066, Uintah County, Utah

Date of Inspection: May 21, 2004
Time of Inspection: About 9:15 to 10:15 a.m.
Conditions: Partly cloudy, 40's
Participants: Gil Mitchell, Brad Dixon, and Merrill Bertosh (not sure of the spelling) representing Deseret Generation; Chauncie Todd and about three other people representing Ashley National Forest; Pete Sokolosky of the Vernal BLM; and Paul Baker, DOGM

M/047/066, Deseret Generation and Transmission, Diamond Mountain Mine

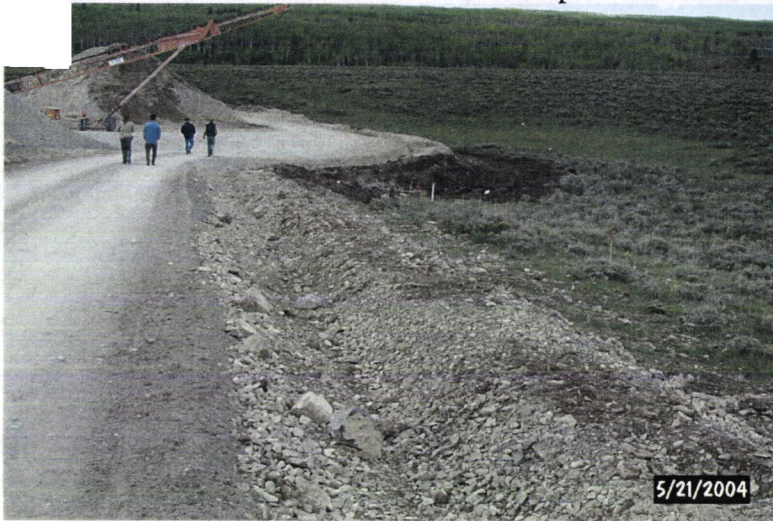
There are berms that would catch runoff from nearly all of the disturbed area (Photo 1). I believe these berms would channel runoff into the pit, but I am not certain.

Photo 1. Berm along the west side of the property. The outside of the berm has been seeded.

The operator should ensure that drainage from the mine is contained on site.

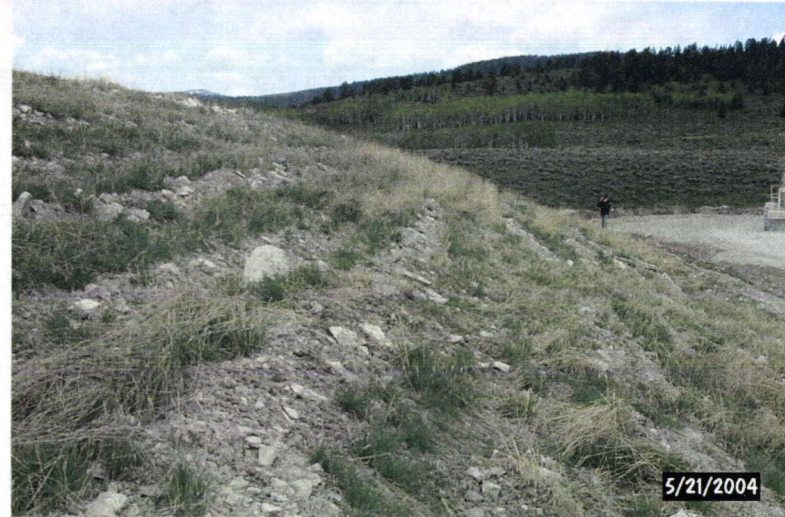
Photo 2 is of an area that was seeded in 2002, and the vegetation is progressing well. The operator added some seed in 2003, and I found numerous seedlings from this effort. Another area on the east and the berms were seeded in 2003, and there were also a lot of seedlings in these areas.

Photo 2. Revegetated area on the south side of the quarry. There is this much vegetation in spite of the drought, and there are numerous seedlings not visible in this photo.

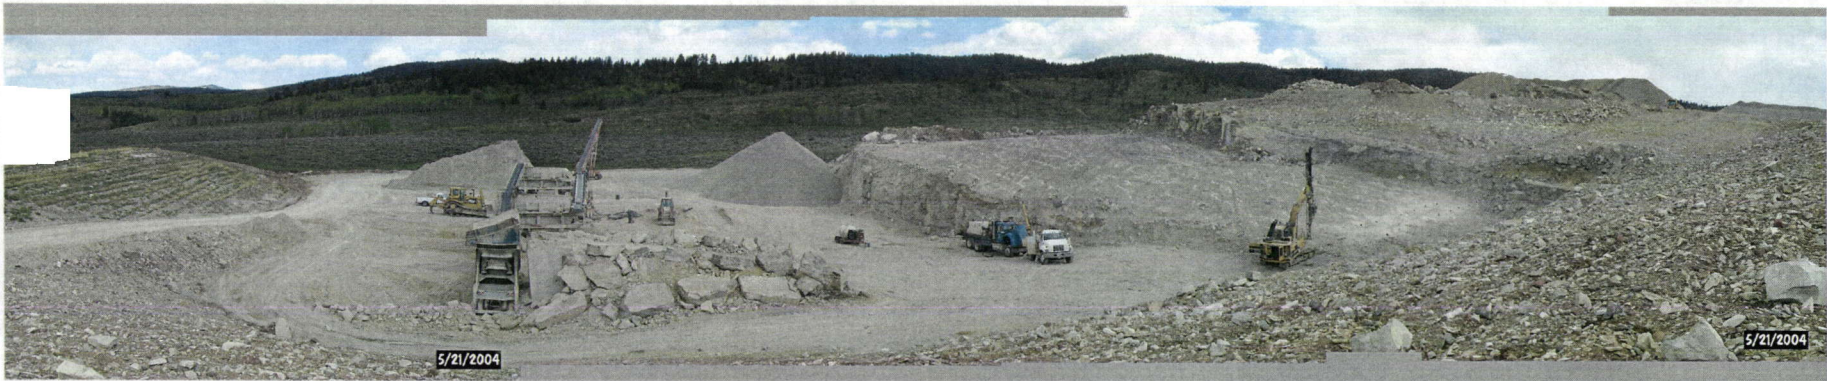
Crushing and screening operations have been moved to the pit floor (Photo 3), but there are still some stockpiles of material in the disturbed area above the pit.

Photo 3. Panorama of the quarry area near the south end of the disturbed area. The revegetated area shown in Photo 2 is on the left of this picture.

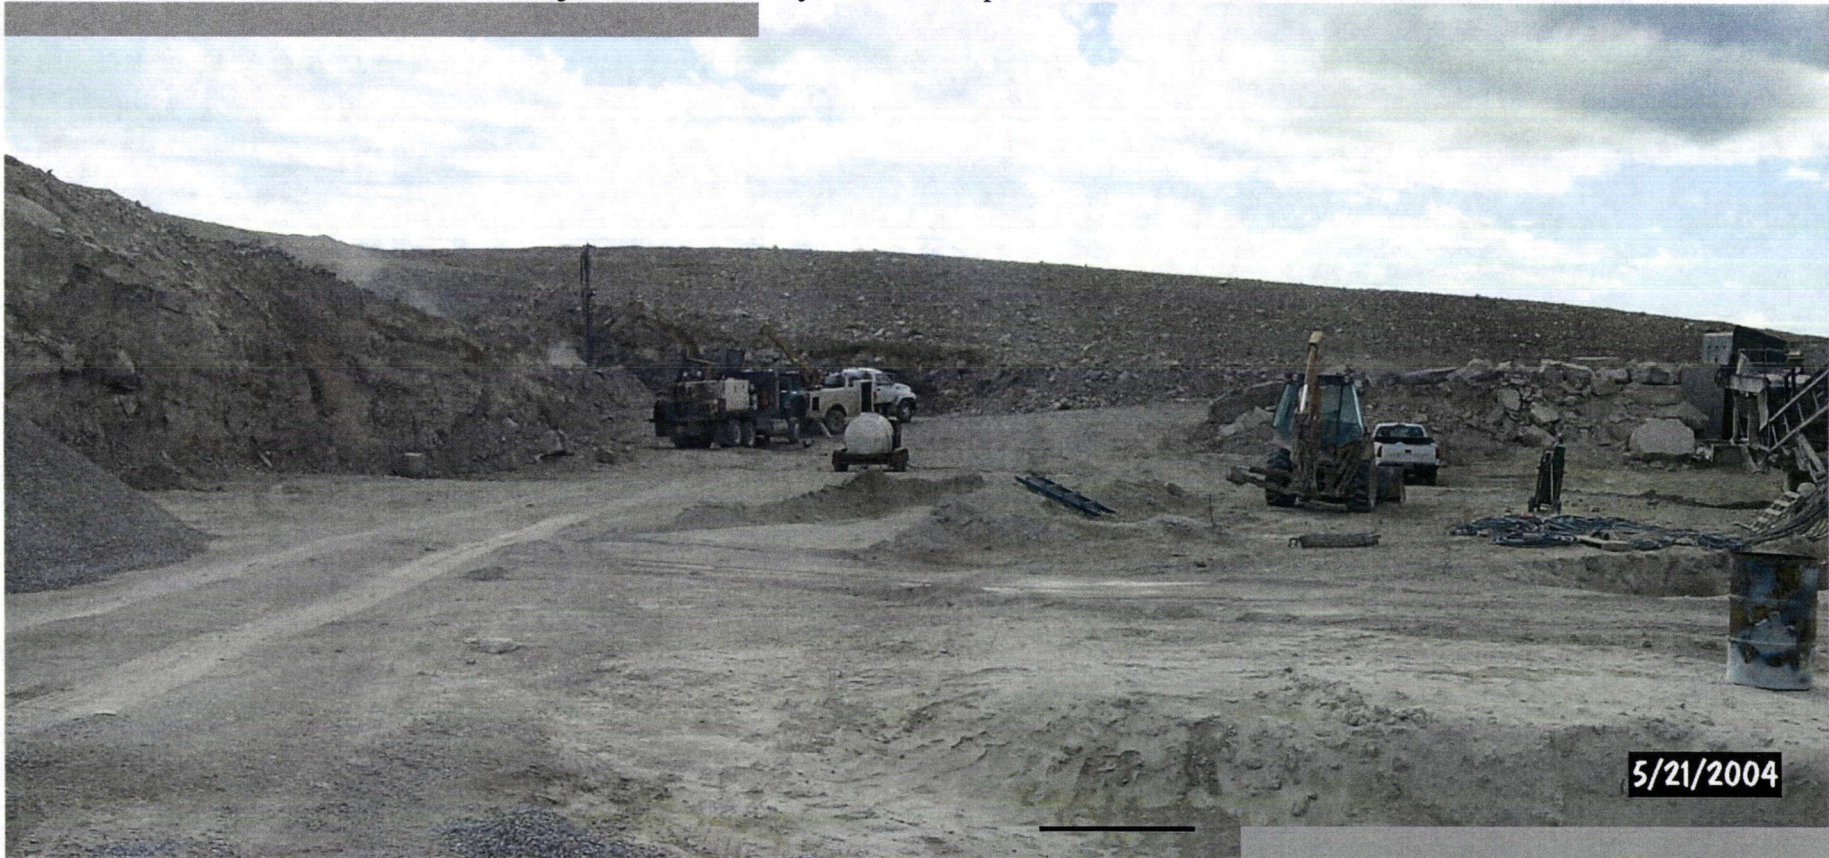
Photo 4. A portion of the operations in the pit.
